Voice of America Mall Target Project: A Steel Push Pier Underpinning Case Study

by Howard Perko, Bill Bonekemper, Dave Jacob and Brian Dwyer
Magnum Piering, Inc., West Chester, Ohio

March 18, 2003

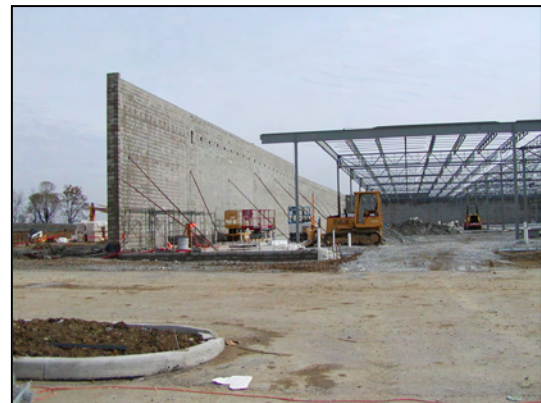
The first wall that the owner, the construction manager, and Dwyer's Dave Jacob visited was the north wall – the wall with the most severe problem. A considerable crack in the interior concrete slab was immediately apparent, and it measured approximately 1/2" to 5/8" wide at its worst point. The crack ran adjacent to the wall for approximately 200 feet and ranged in distance from 3 to 4 feet from the wall's base. The two men quickly pointed to some hand written measurements marked at eye level on the wall about every 20 feet. As they explained to Dave, these markings represented the distance the north wall had rolled outward (to the north) at the top of its 27 foot height as measured by the steel contractor on October 10th. The measurements ranged from a minimum of 1/8", close to both the west and east corners of the wall, to a maximum of 2-3/4", near the center of the wall's 310-foot total length.

Fig. 1 North Wall of Target Store Under Construction

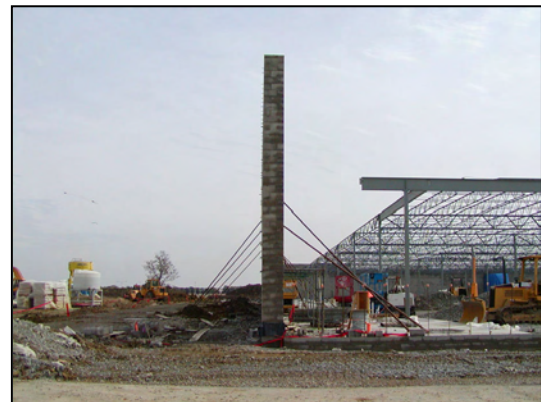
eastern district, and the two men explained to Dave that there was a serious foundation failure on the north and south walls of this 120,000 sq. foot store. The problem was described to Dave as critical because all steel roofing and steel structural work had been shut down. After this brief introductory meeting, the three men went to view the problems with the walls. Photographs of the site before repair are shown in Figs. 1 and 2. As can be seen in the figures, the store was in the early stages of construction. Concrete masonry unit (CMU) block walls had been constructed and were temporarily braced for wind

Fig. 2 North Wall of Target Store Showing Lateral Bracing

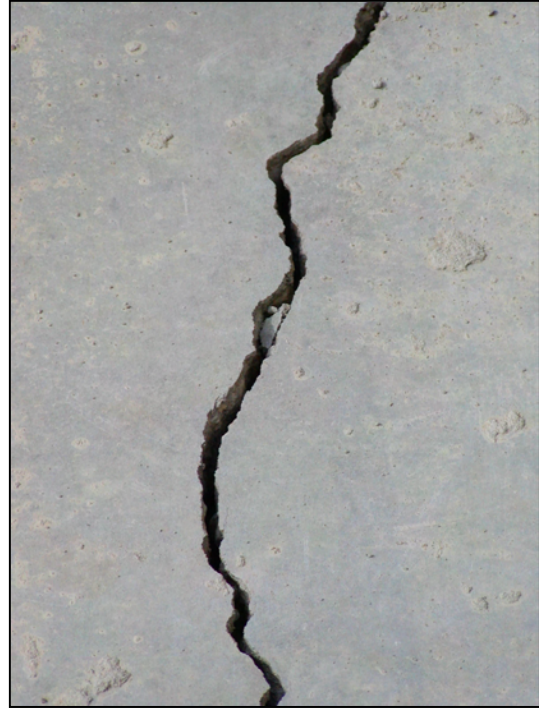
Fig. 4 Close-up View of Example Floor Slab Crack

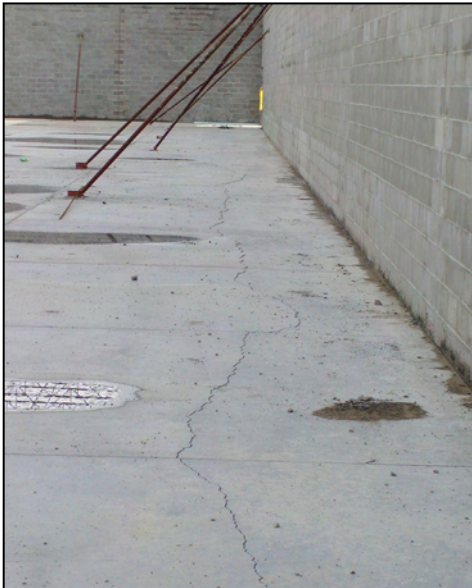
When the three men finished discussing the conditions at the north wall, they quickly went to examine the similar conditions at the structure's south wall. Although the settlement and subsequent outward roll of the south wall was not as severe as with the north wall, the top of the south wall had rolled outward (south) 1-7/8" inches near the center of the wall's 260 foot total length, as recorded by the steel contractor. The concrete slab also had a crack similar to the crack at the base of the north wall. The slab crack is shown in Figs. 3 and 4. A similar foundation design change had been made on this side of the building due to the close proximity of the property boundary. The foundation failure of the south wall was again attributed to the eccentric loading on the spread footing for the first approximately 200 feet of the wall measuring west to east. A photograph of one of the cracks in the CMU block wall is shown in Fig. 5.

Fig. 3 Example Floor Slab Crack Adjacent to South Wall

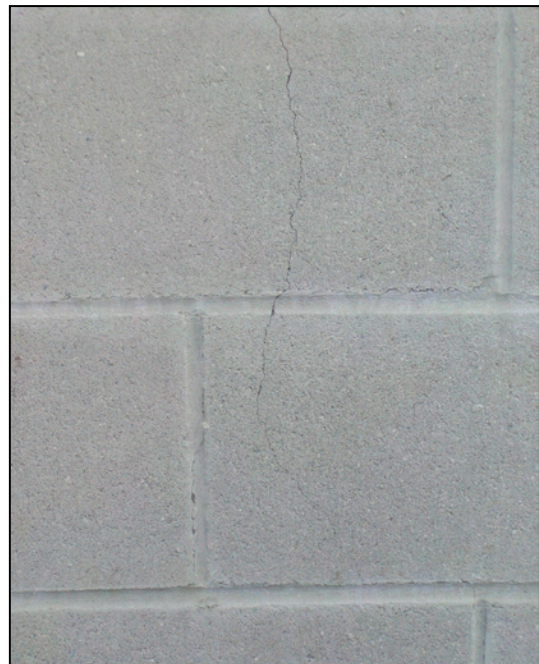
Fig. 5 Example Vertical Crack in South Wall of Target Store

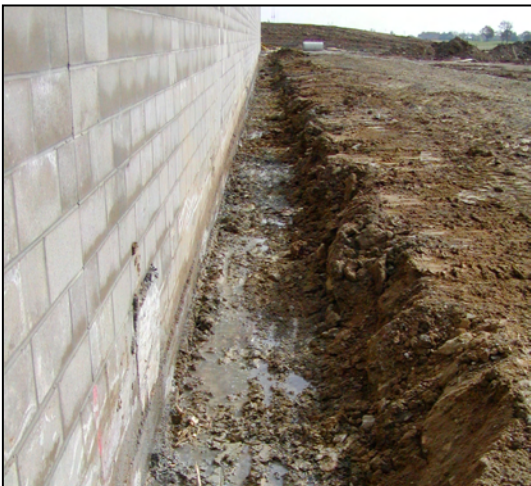
Due to the close proximity of the adjacent property line, the design was changed and instead the first approximately 250 feet of the wall's footing was shifted inward and constructed flush with the exterior alignment of the CMU block wall. This change in the foundation design, in conjunction with heavy amounts of rain at the site for several days, were deemed, by Elford's structural engineers and the contracted geotechnical firm for the project, to be the sources of the failure.

Adjacent property lines to the south and north walls were extremely close. In fact, the store width was only 8 inches smaller than the lot width. This condition necessitated that the foundation had to be virtually flush with the block wall as shown in Fig. 8.

Fig. 8 As-Built Spread Footing Shown Nearly Flush with Exterior Wall

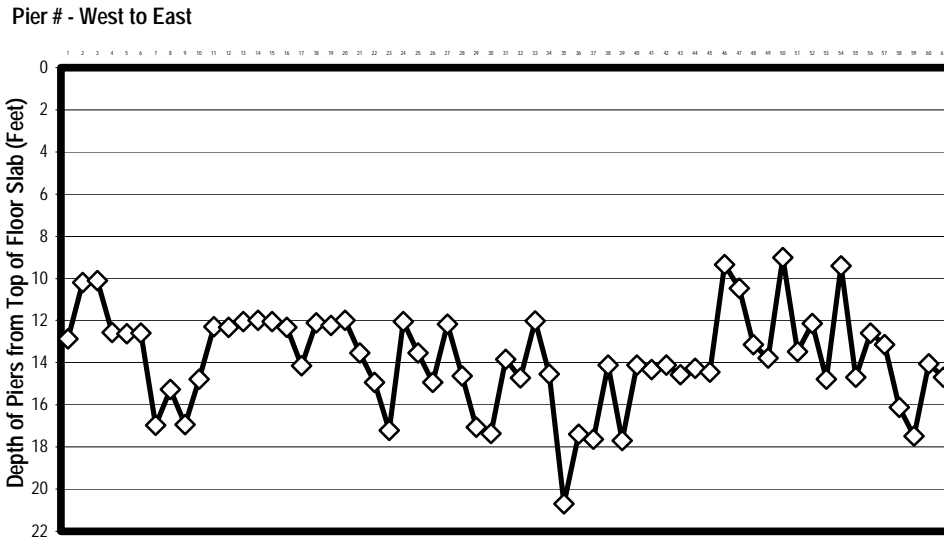
As can be seen in the figures, the final depth of the piers along the North wall varied from 10 to 20 feet below the top of slab and along the South wall from 15 to 19 feet. In either case, a discernable profile is evident. The reason for larger variation in pier depth on the North side of the site is unknown. However, the depth of the piers was generally consistent with the depth and variability of bedrock described in the geotechnical engineer's report for the project site. It was concluded that all piers are likely supported on or within the bedrock.

Fig. 14 Final Pier Depths Along North Wall

At the Target Store, the design ultimate capacity of each pier was 35 kips. In order to add to the factor of safety and ensure proper pier installation, Dwyer personnel installed each pier to the maximum load that could safely be applied to the structure (40 kips), which corresponds to a hydraulic ram pressure of approximately 5,000 psi. The final depth of the piers along the North and South walls of the building are shown in Figs. 14 and 15.

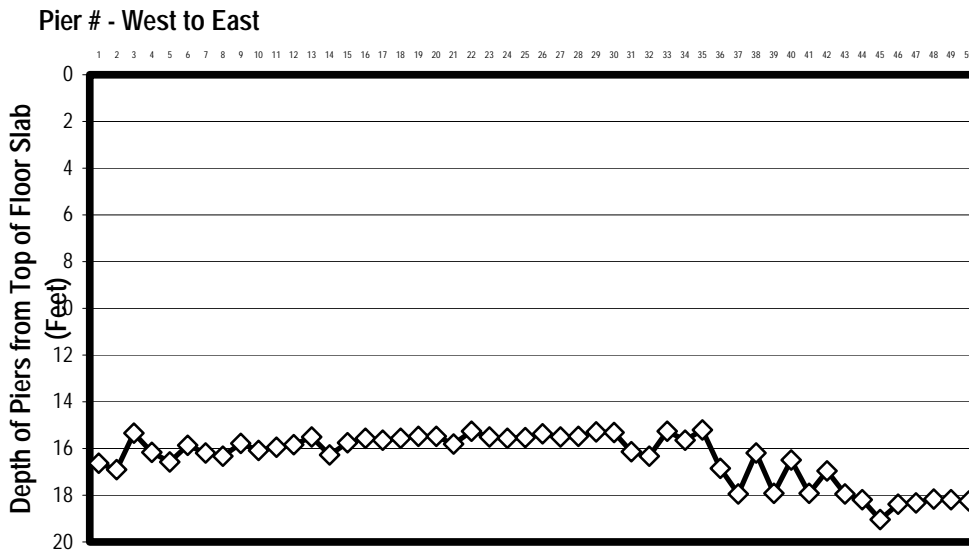
Fig. 15 Final Pier Depths Along South Wall

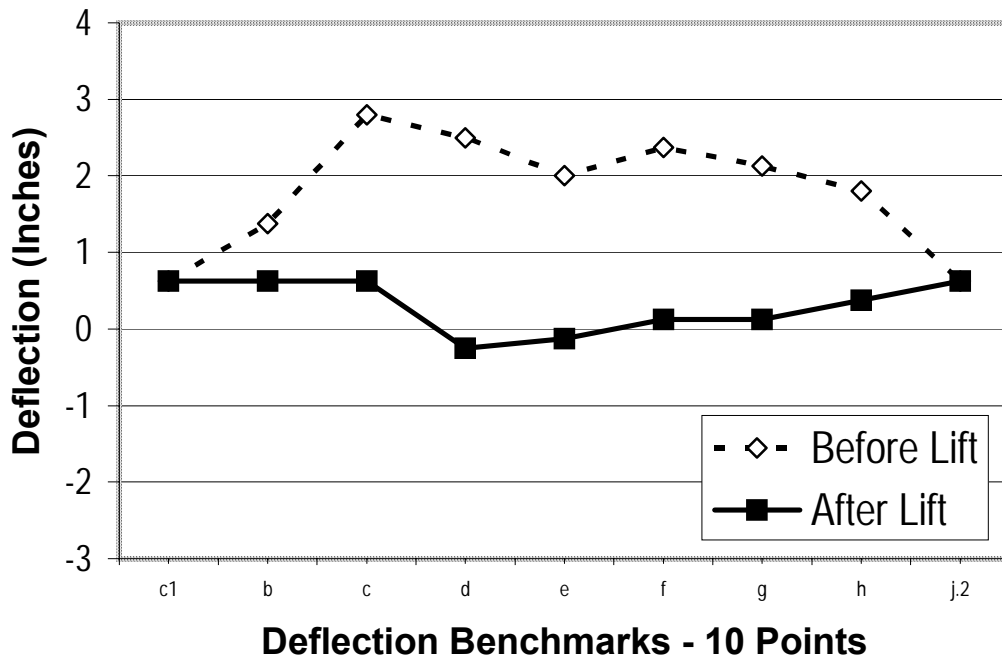
Fig. 16 Initial and Final North Wall Top Location

Both walls were successfully relocated. Initial and final top of wall locations with respect to plumb are shown in Figs. 16 and 17. The North and South walls were restored to within ½ inch of plumb, except for the Eastern portion of the South wall. The reason for this discrepancy is that the wall was not constructed perfectly straight. It was identified during this phase that the South wall had started to settle during masonry construction, and the block mason had to adjust the course of the wall. Afterward, the wall continued to move and eventually ended in the position where Dwyer was called to the site. The wall could not be improved beyond that shown unless it was reconstructed. It was deemed that the lift was acceptable and the underpinning project was completed.

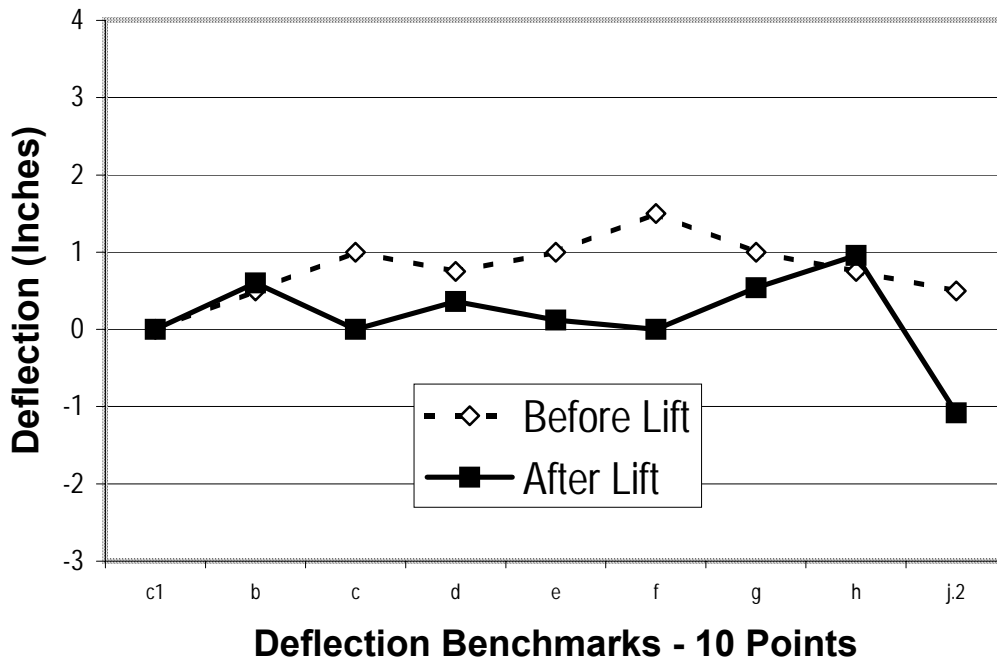
Fig. 17 Initial and Final South Wall Top Location
